Comprehensive Bridge Deck Deterioration Mapping of Nine Bridges by Nondestructive Evaluation Technologies

Final Report
January 2011

Sponsored by
Iowa Highway Research Board (IHRB Project SPR-NDEB(90)--8H-00)
Iowa Department of Transportation
Federal Highway Administration

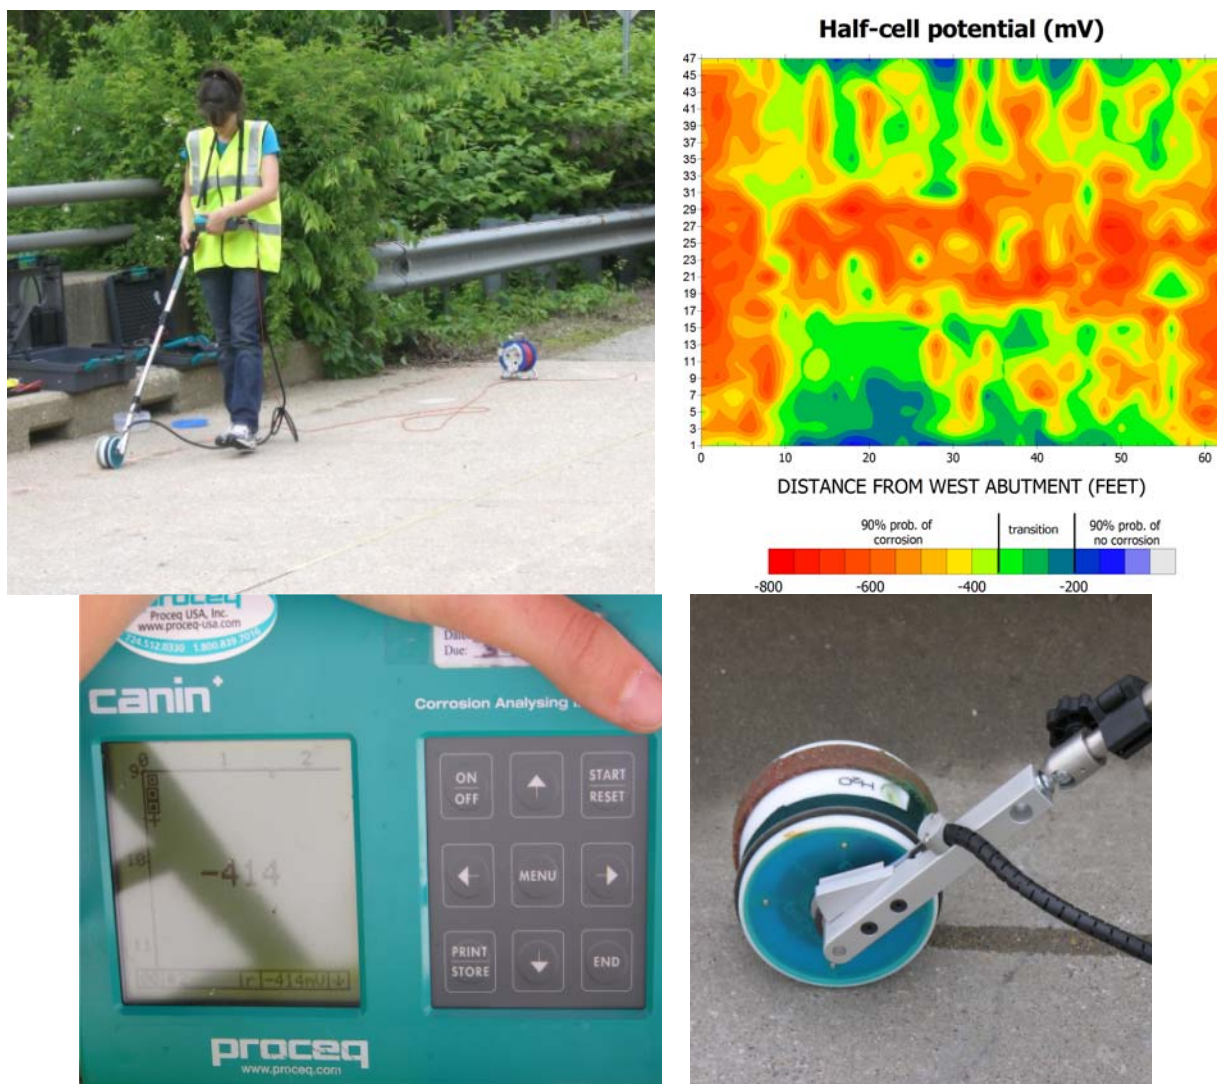
Figure 37. Half-cell potential measured on bridge deck (top left), example of mapped results (top right), images of control/display (bottom left) and electrode wheel (bottom right).

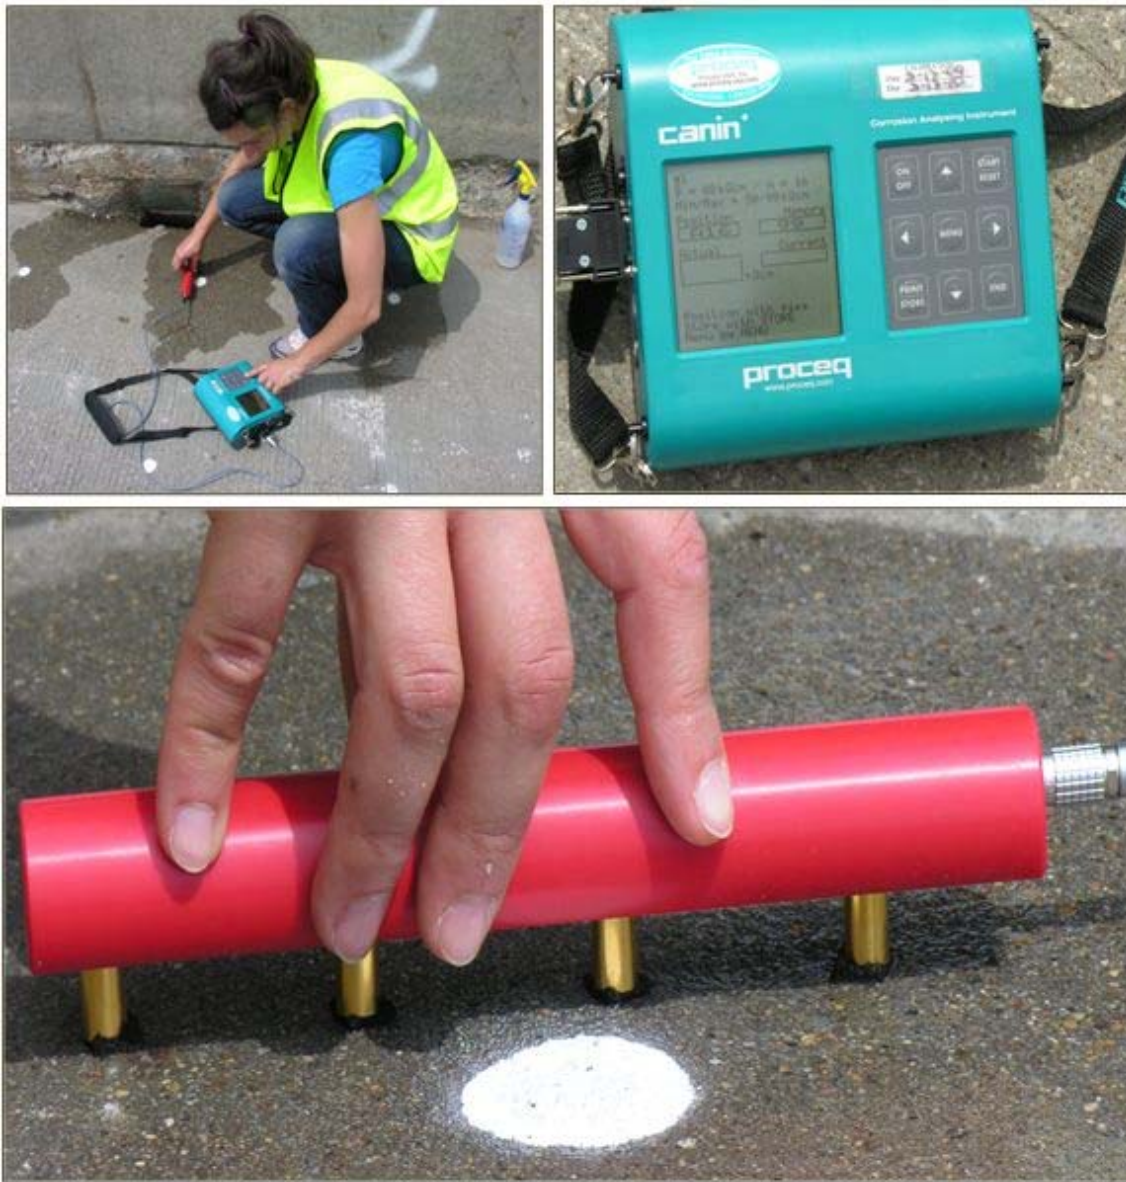
Figure 52. Electrical resistivity (ER) measurements obtained using a four-probe Wenner array.

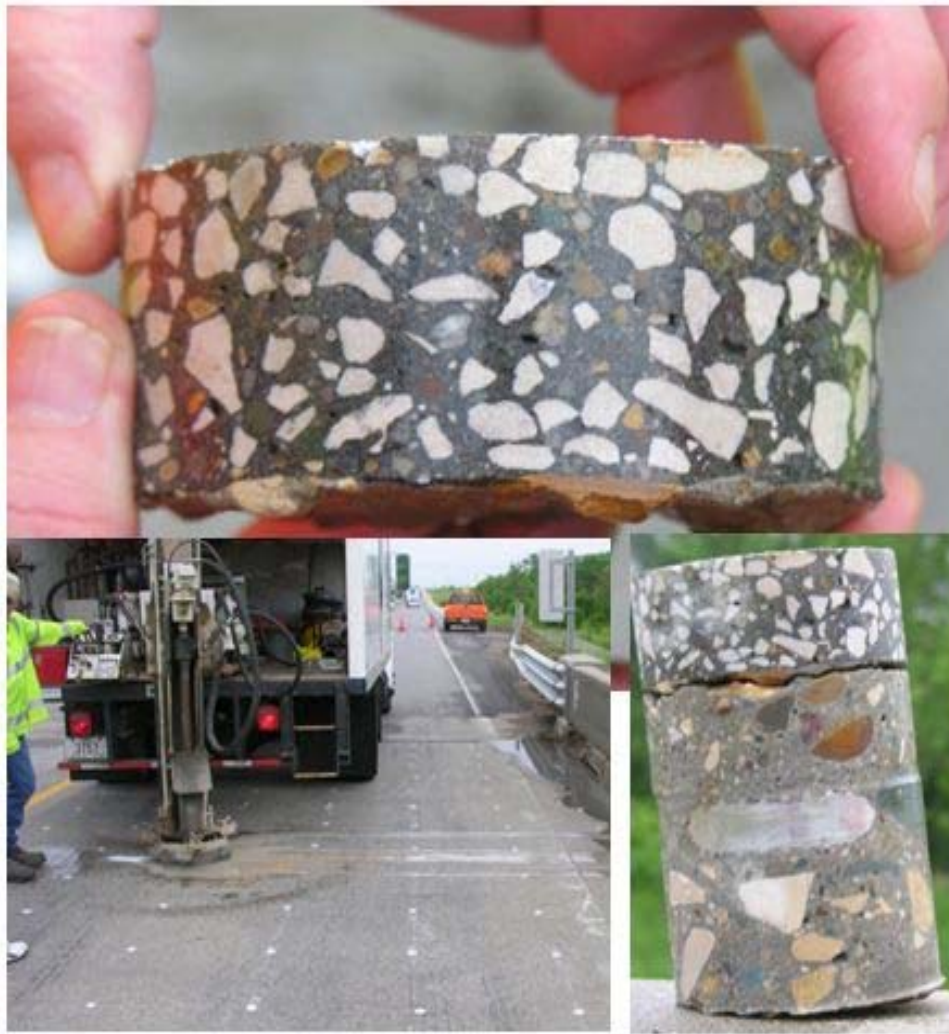
Figure 59. Core 1, showing debonding, but no obvious evidence of concrete deterioration at the rebar level, though raw GPR data used to select core location indicates such.

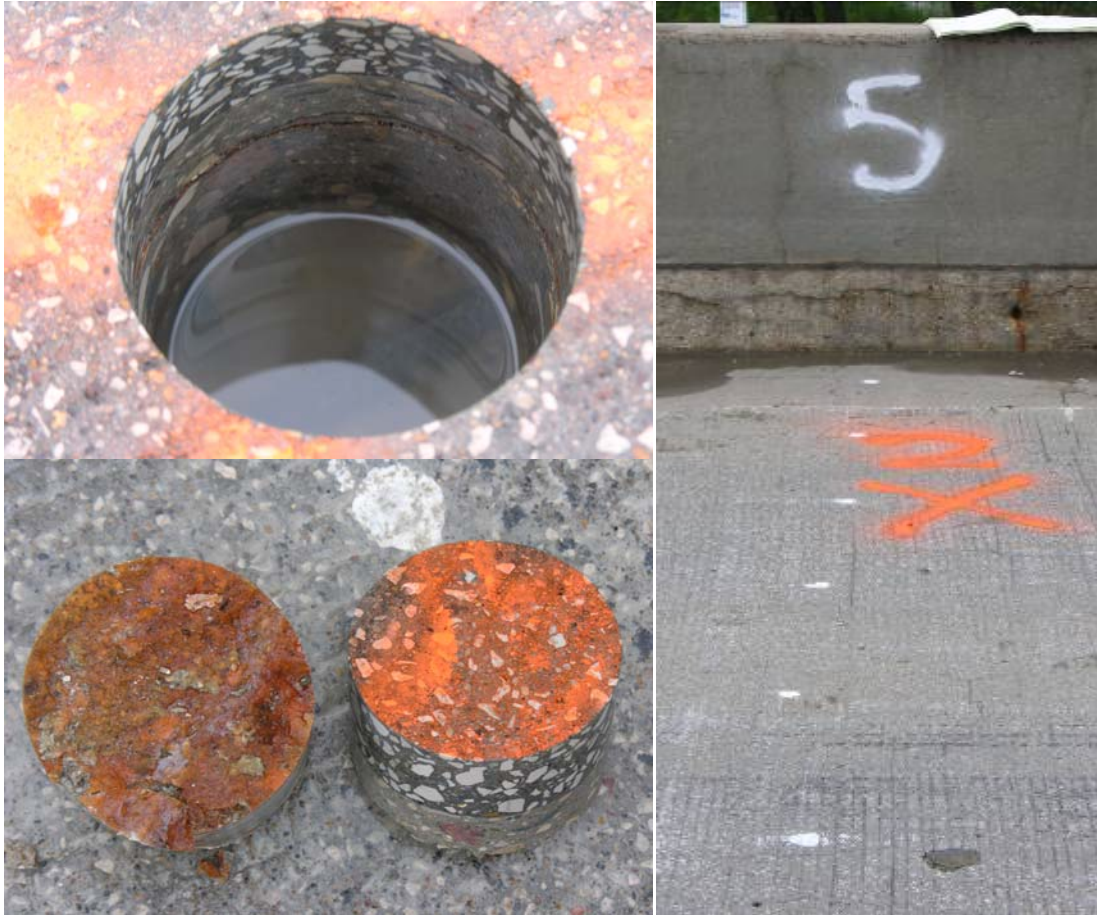
Figure 62. Photos of Core #2 location, showing extracted core, epoxy-filled delamination in core hole, and bonded overlay.

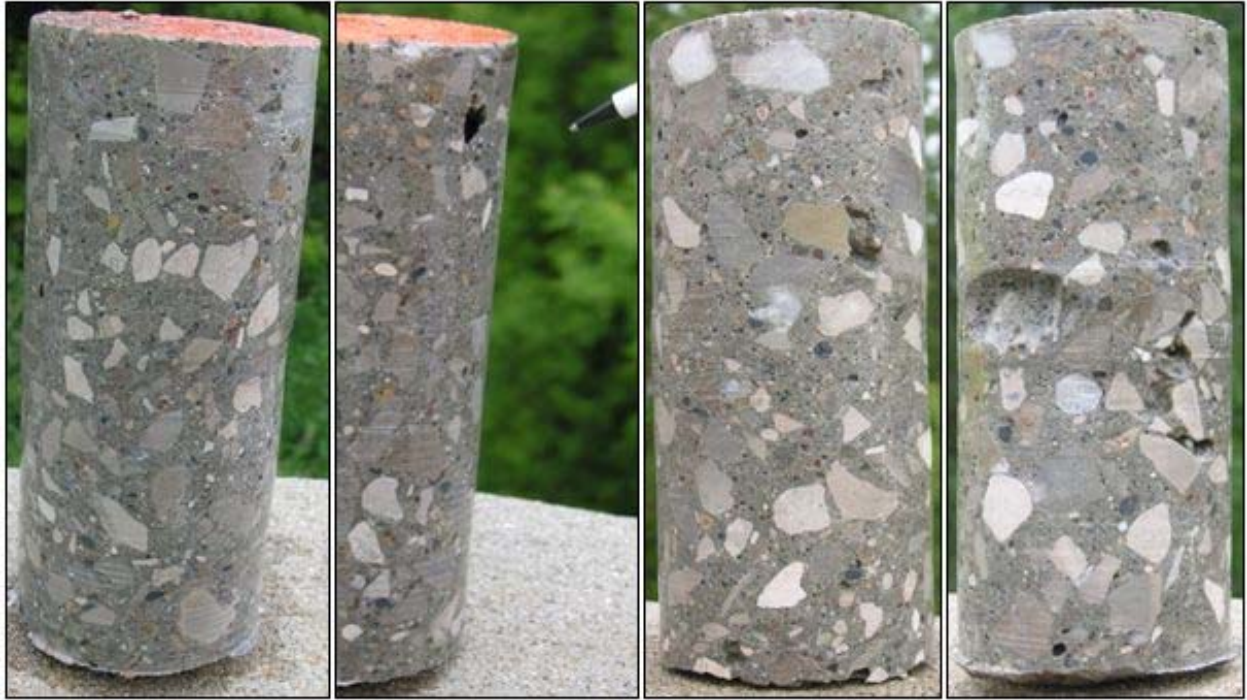
Figure 82. Cores 1 through 4 (left to right), where Core 1 is “control” and Cores 2 to 4 selected where GPR signal looked “slightly worse”, yet not obviously deteriorated. Note pen-sized vug in Core #2.

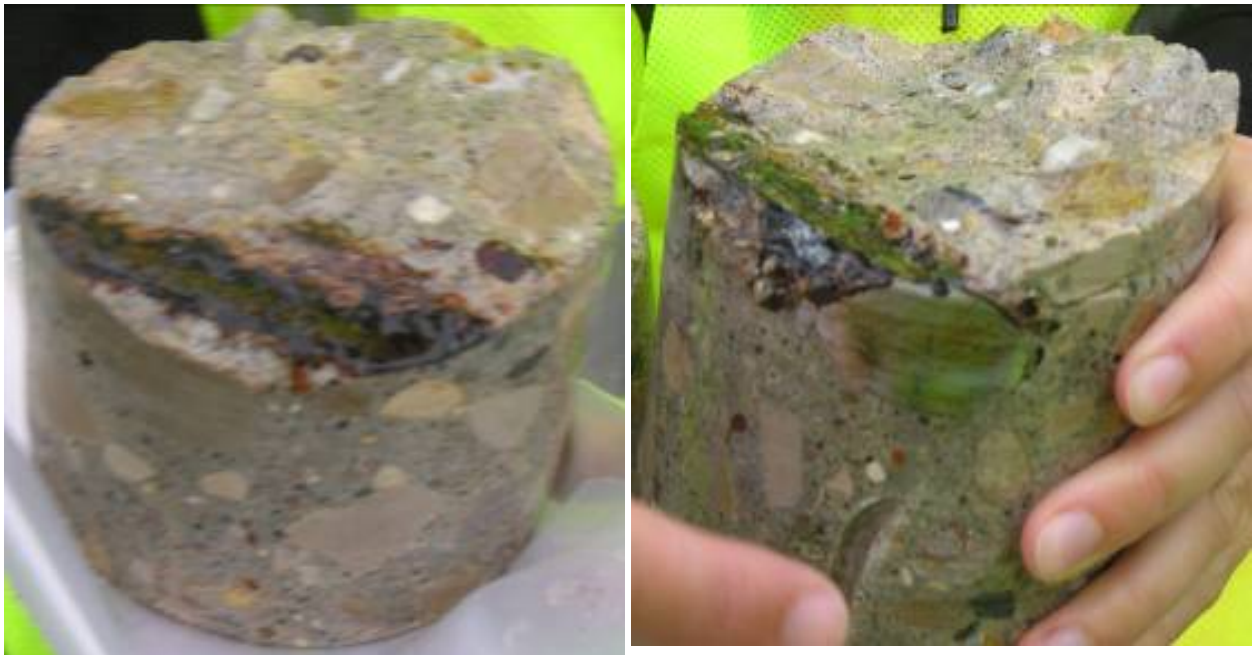
Figure 91. Top of Core #4 (inverted, left) reveals corrosion products above delamination; core bottom (right) with corrosion products on top and sides of rebar.

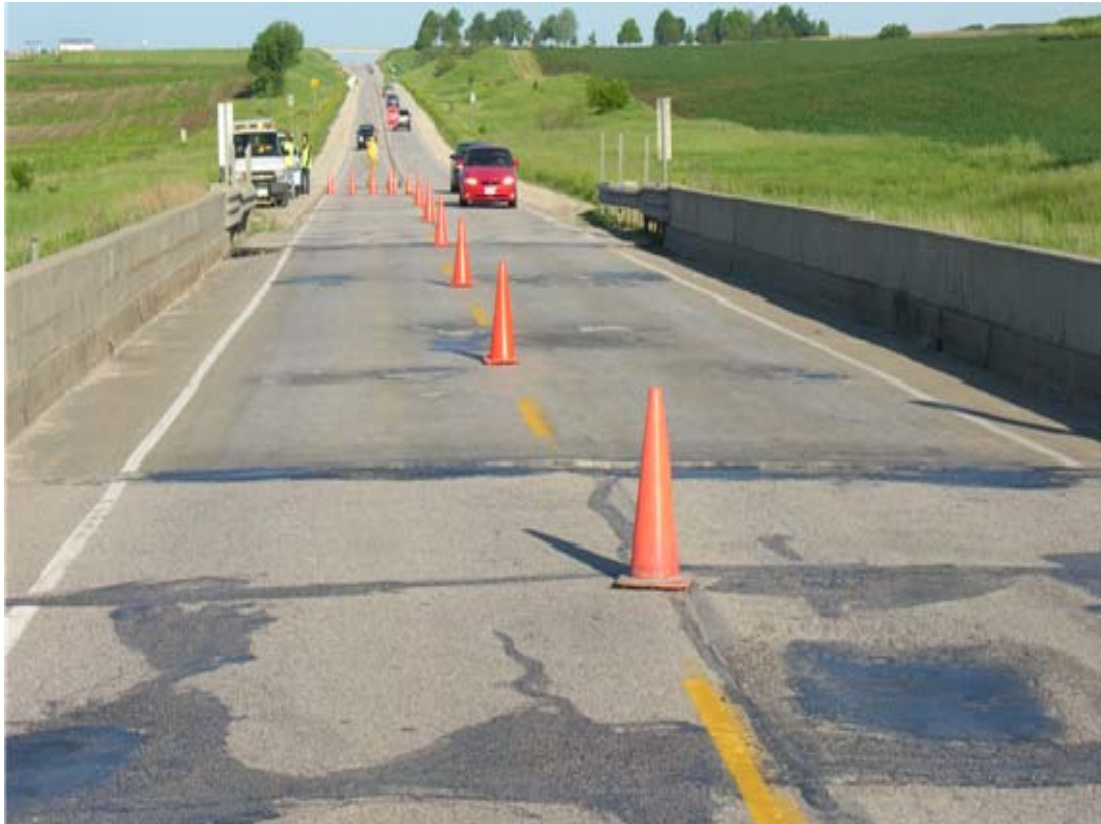
Figure 96. Perspective view of Deck O5, showing patches and spalls; also, repaired settlements in approach slab (foreground).

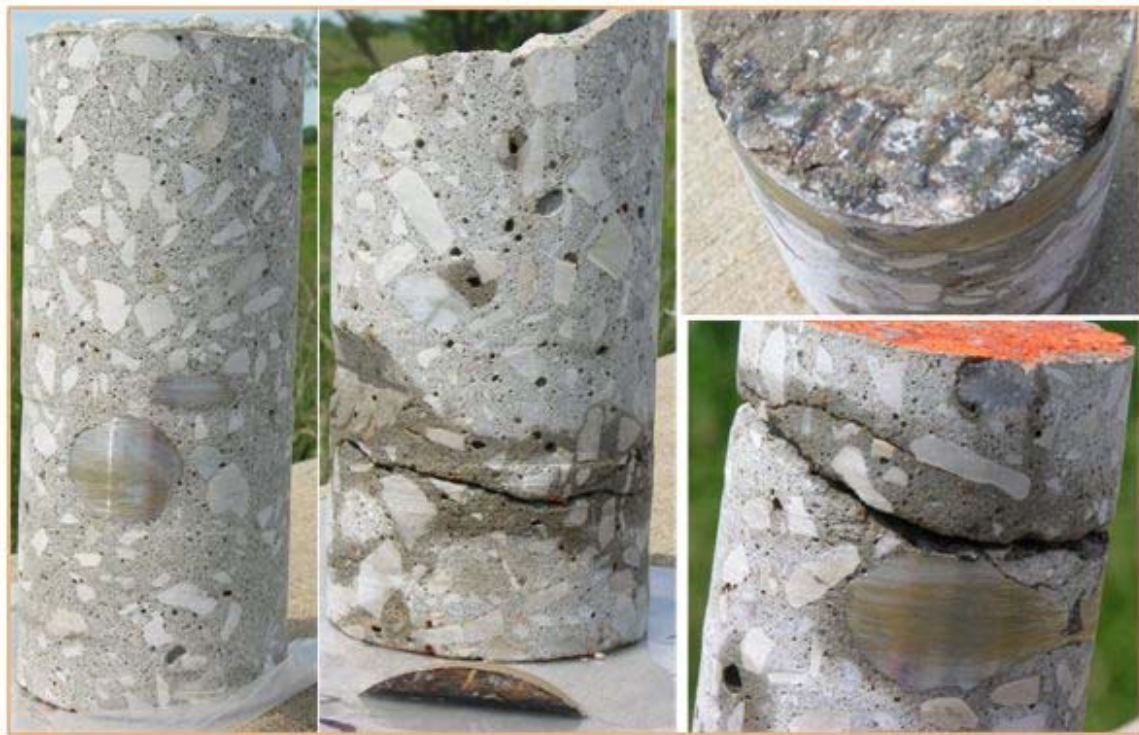
Figure 101. Cores 2, 3 and 4 are shown left to right, respectively, with control (good) core at left.

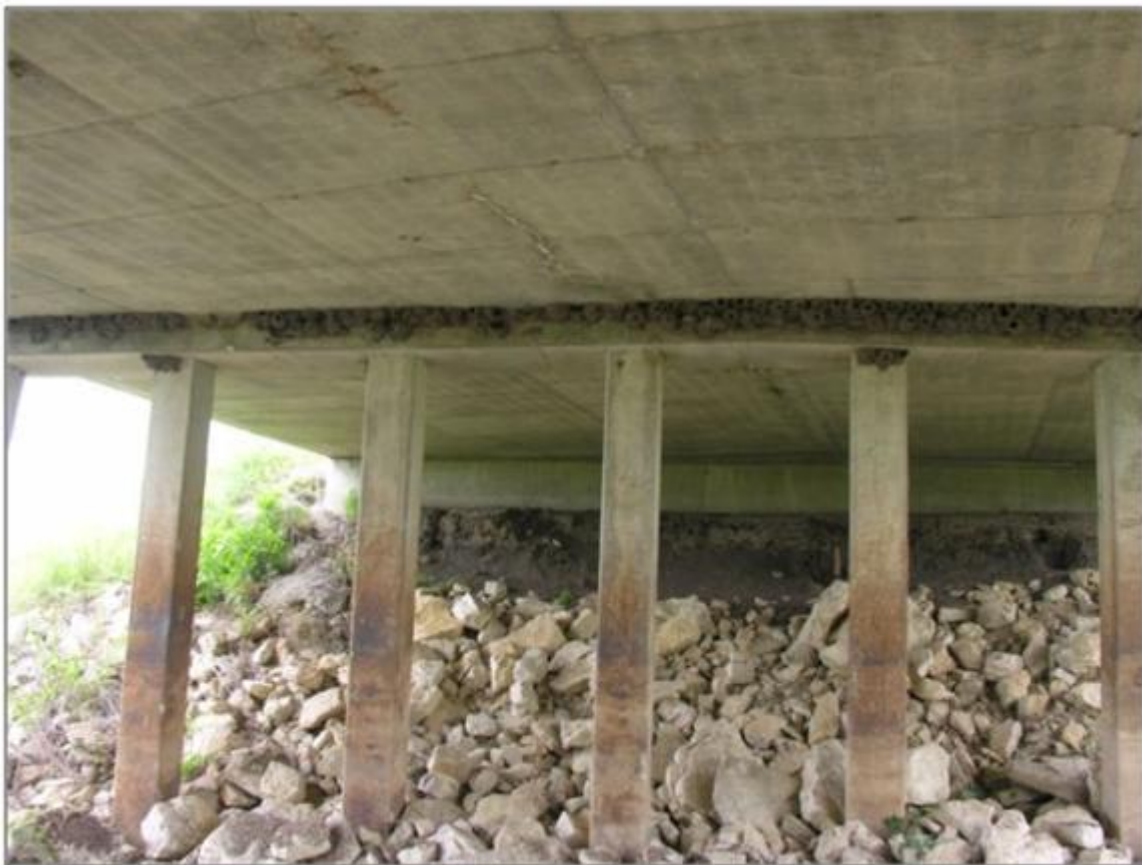
Figure 105. Bottom view of Deck O6 (continuous slab) shows rust staining, efflorescence and swallow nests along entire deck underside at pier.

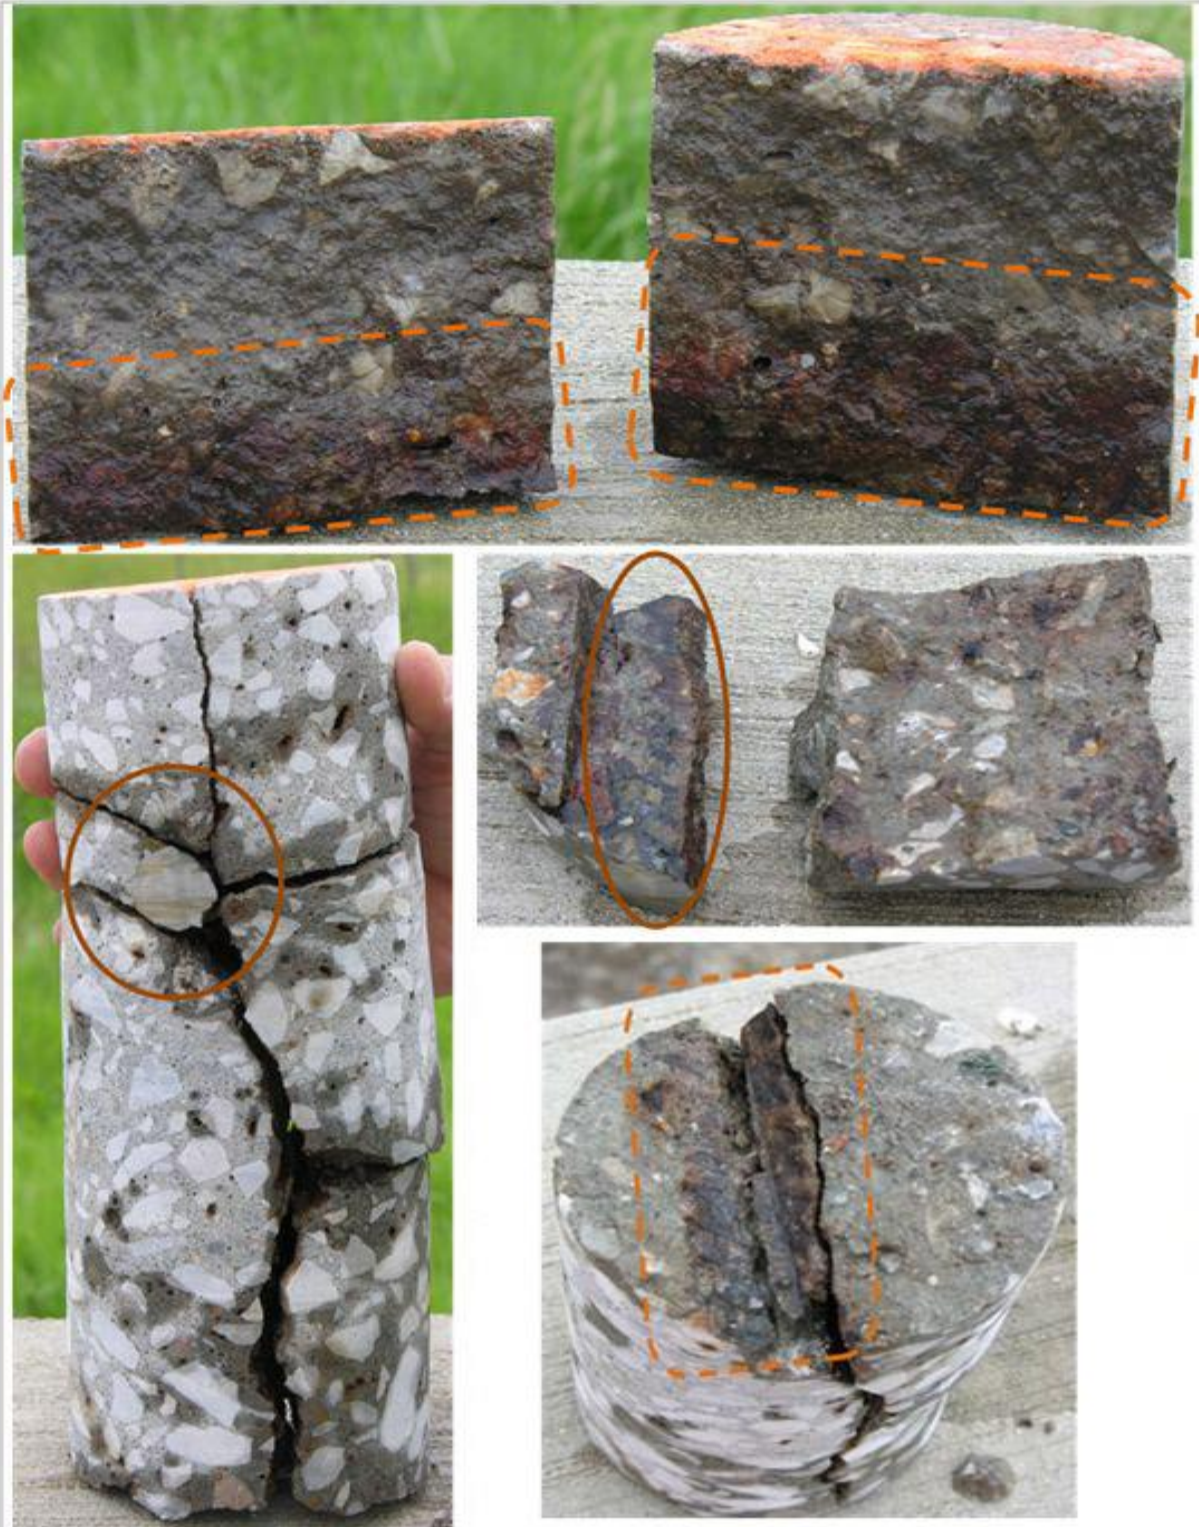
Figure 112. Core #3, retrieved in six pieces, extracted above longitudinal bar at surface crack.

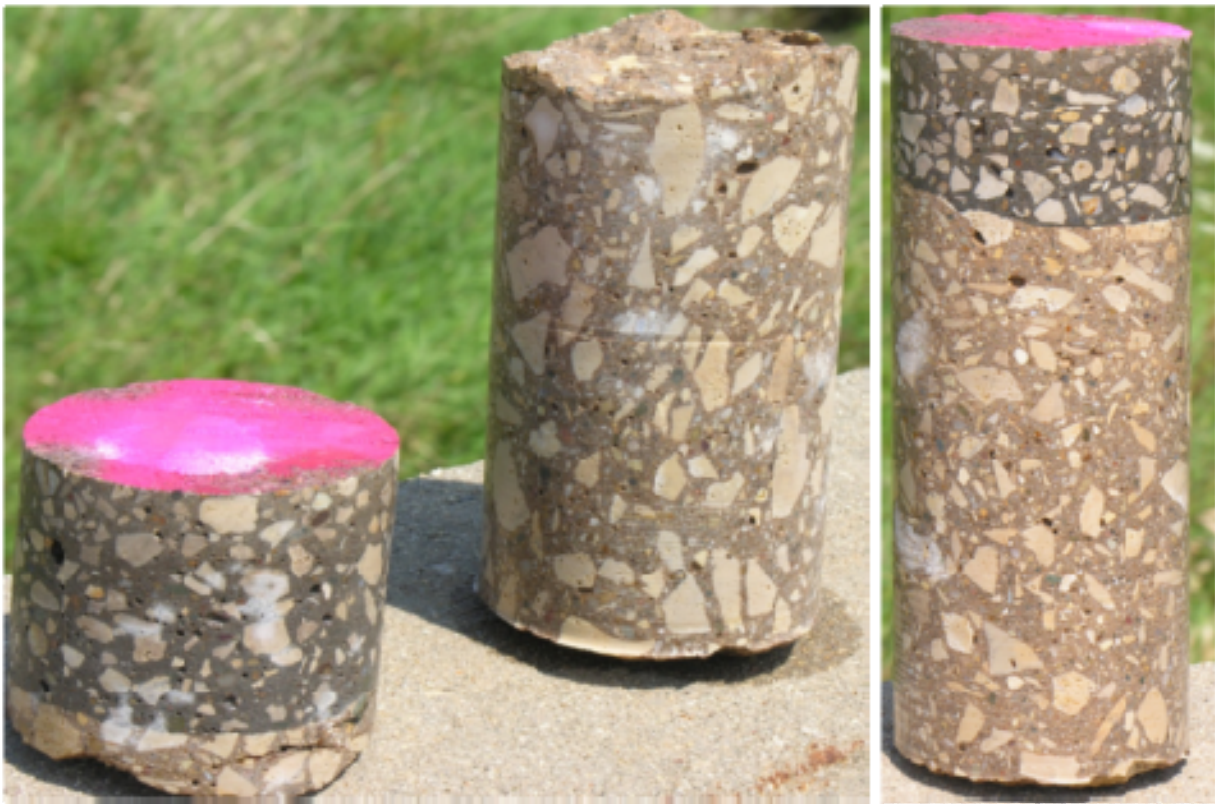
Figure 121. Cores 1 & 2 (left and right), graded “serious” (delaminated) and “good” (intact) using IE.
